**SUBJECT: Request for Water Quality Certification**  
Pike County, KYTC Item No. 12-1076.00 & 12-1089.00  
Bridge Replacements on KY-199

Kentucky Transportation	PROJECT: KY 199		STREAM: Pond Creek & UT's		
	COUNTY: PIKE	STATE: KENTUCKY	Bridge Replacement Projects	ITEM: 12-1076, 12-1089	VICINITY MAP

## SUMMARY OF IMPACTS

### Item No. 12-1076.00 & 12-1089.00

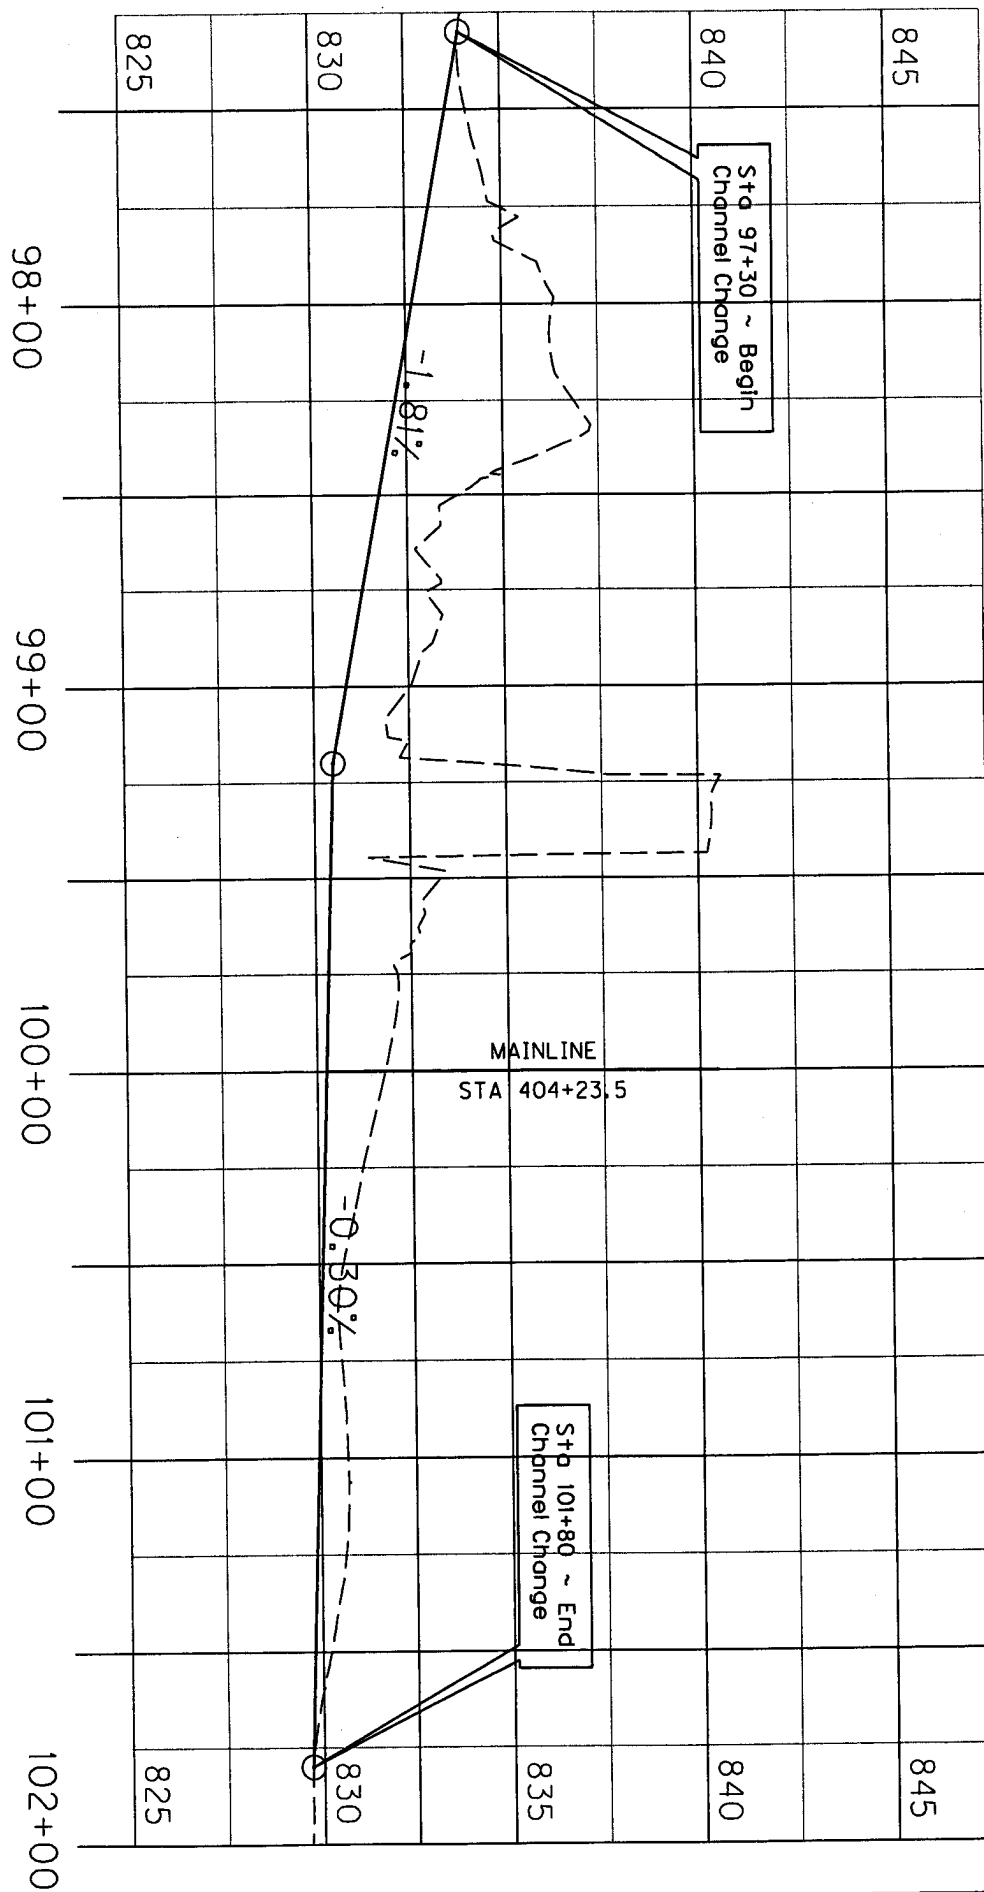
SCALE: 1"=50' HORIZONTAL  
1"=5' VERTICAL

STA 101+80  
End Stream Relocation

STA 97+30  
Begin Stream Relocation

1. Sta. 404+23.46 – Replace an existing bridge, and the remaining abutments of another, with one single clear span bridge with 450' of associated channel change; on Pond Creek. This impacts **449' of perennial stream** (Reach 1). The impact to waters is **0.309 acres**. The drainage area affected is **8.78 square miles**. The site is located at N37-33-55, W82-15-51. (Nationwide Permit No. 14, Ind. WQC)

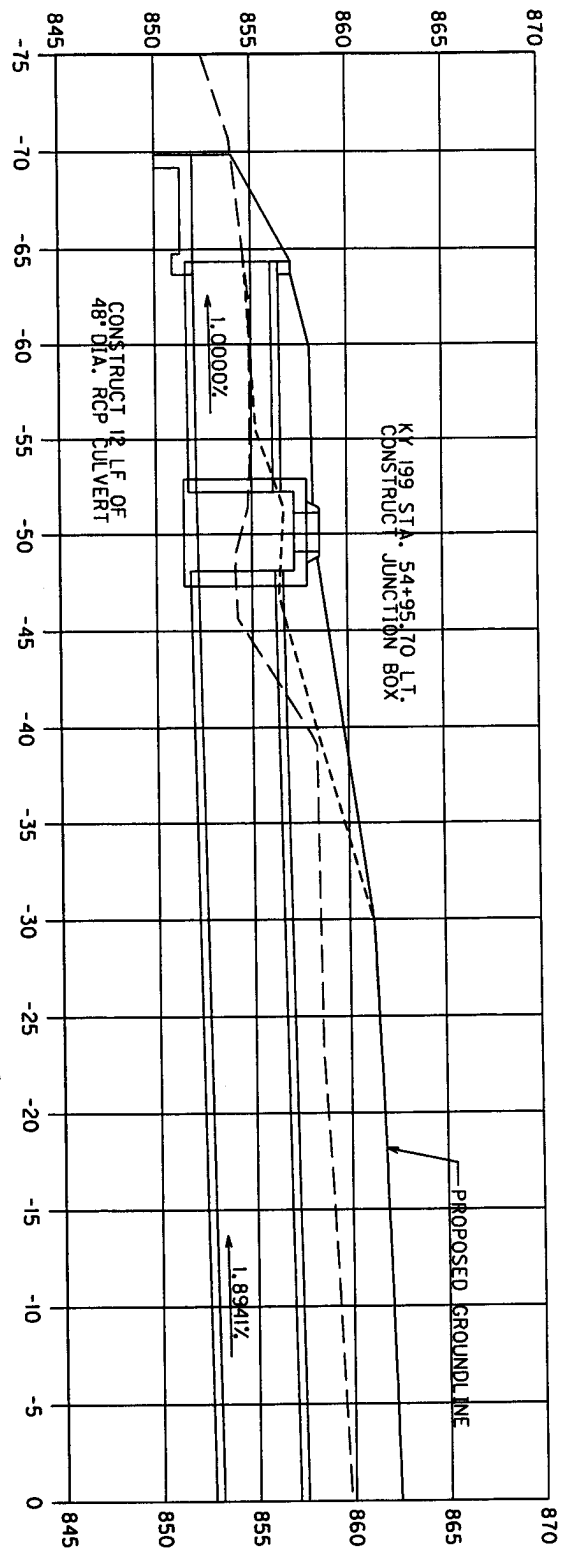
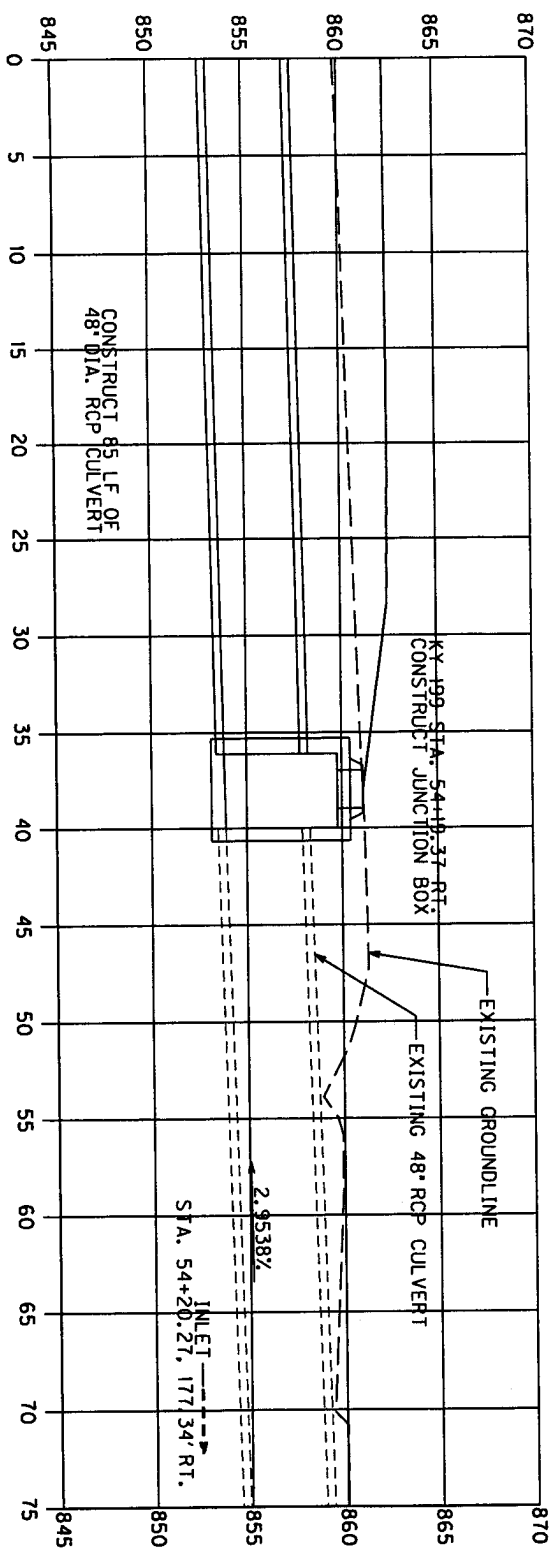
STA. 54+51

SCALE: 1"=10'

4. Sta. 54+51 – Construct a culvert extension, 110' in length, with 7' of outlet channel, on an existing culvert for an **intermittent** tributary (Reach 3) to Pond Creek. This replaces the last **23' of existing pipe**, which outlets at a wall along Pond Creek. The extension relocates the outlet. The impact to waters is **0.003 acres** (23' of culvert). The drainage area affected is **134 acres**. The site is located near N37-33-39, W82-15-37. (Nationwide Permit No. 14)

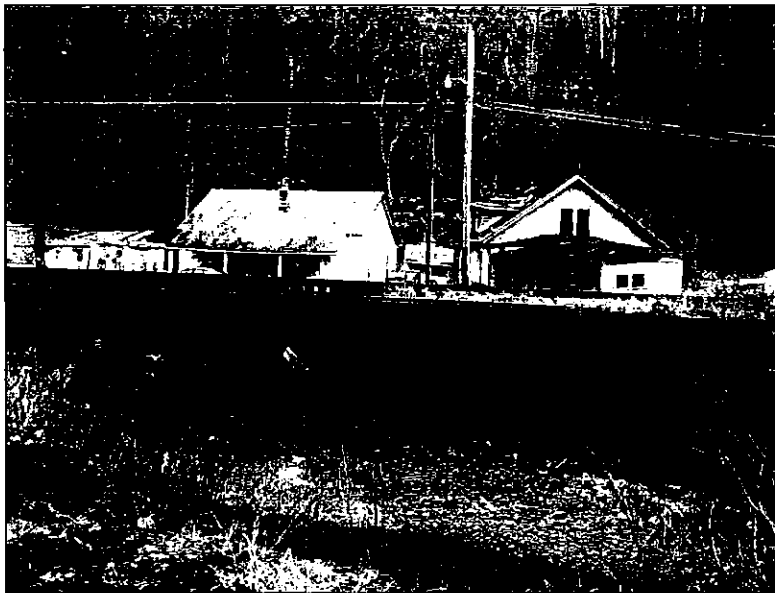
12-1076 Railroad bridge prior to destruction by flood (only abutments remain)

18. REMARKS: The piers and deck for the old railroad bridge (Item No. 12-1076.00) were washed out during a recent flood (emergency work was required to clear stream and banks).

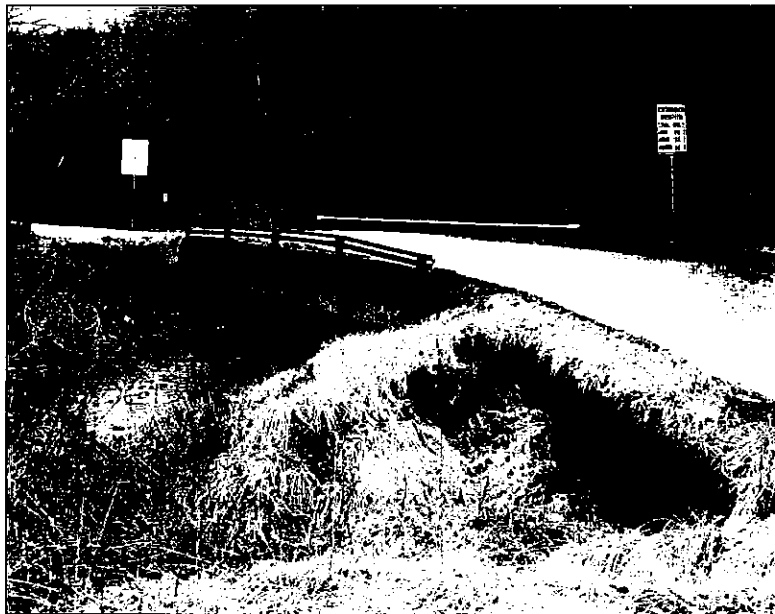
12-1076 Existing KY199 bridge to be removed

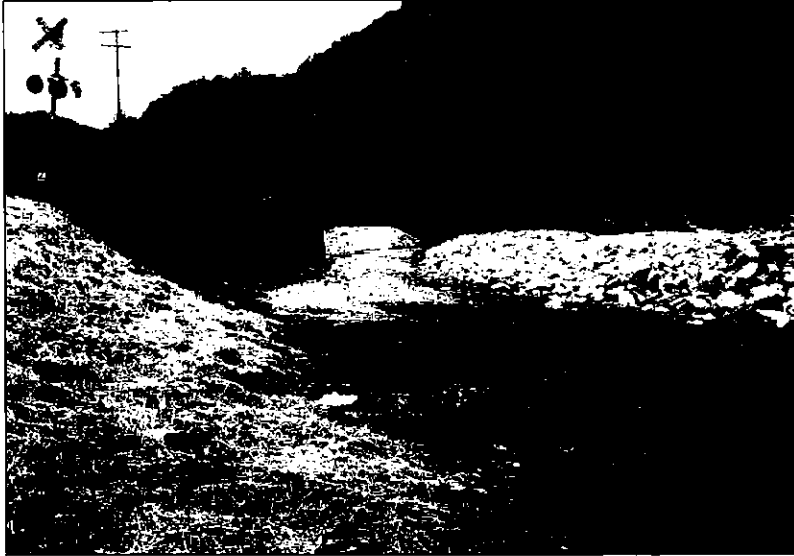
12-1076.00 – Reach 1, looking upstream at RR bridge site

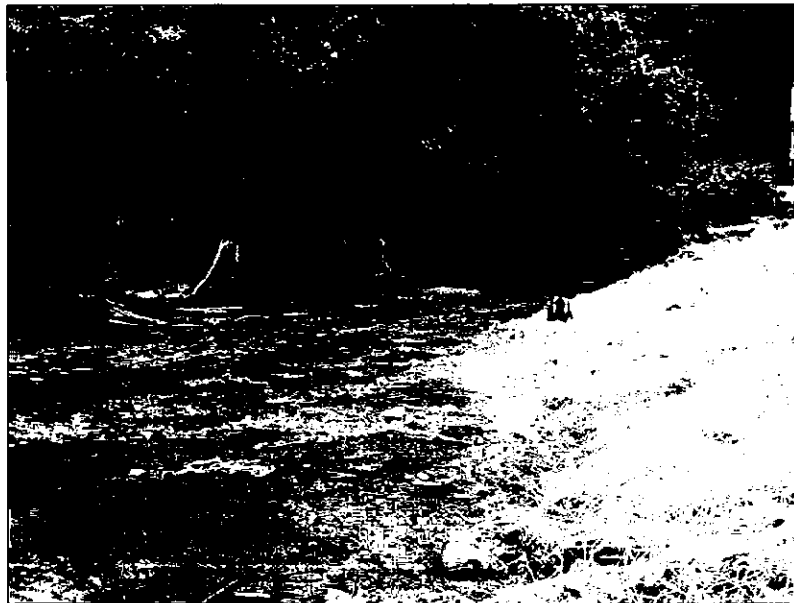
12-1076.00 – Reach 1, looking downstream from RR bridge site

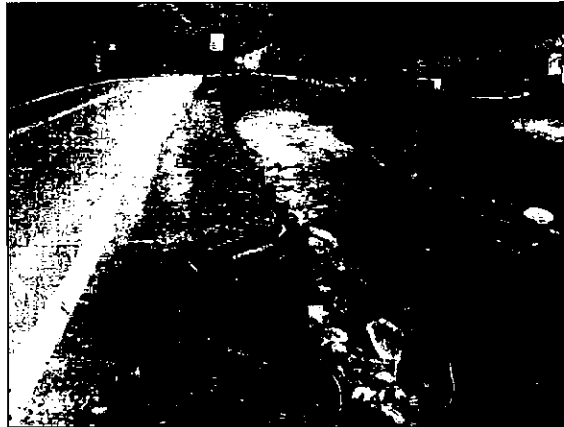
12-1089 Existing retaining wall upstream of bridge

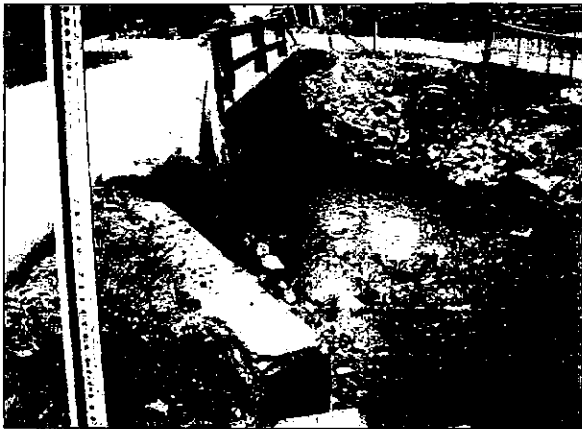
12-1089 Upstream face of bridge

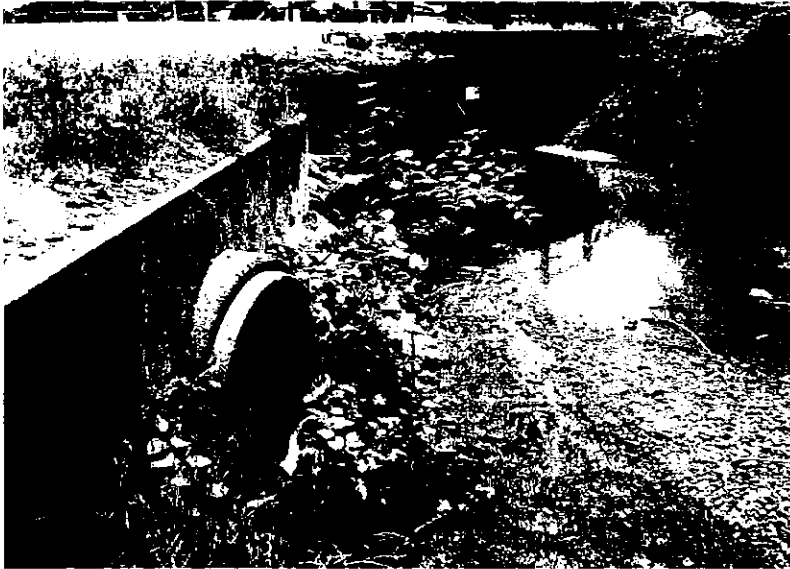
12-1089.00 – Reach 3, looking upstream on Pond Creek at existing culvert outlet

The intermittent stream (Reach 3 at the 12-1089.00 site) is completely encased in a culvert in the area of the project, and outlets at a retaining wall at Pond Creek. The proposed work is to remove a small pipe section and headwall (23 feet) and extend the culvert further downstream, avoiding the new bridge construction area. There will be no impacts to any open channel associated with the intermittent stream, therefore no mitigation is being provided.

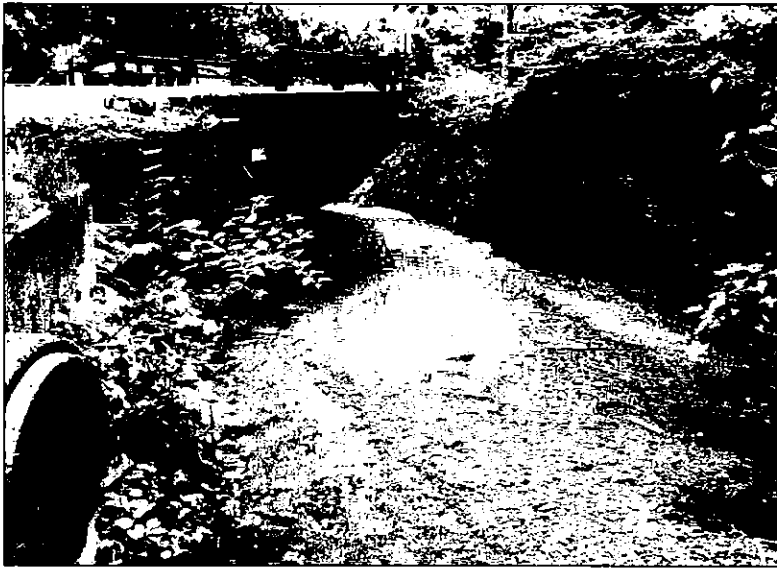
12-1089.00 – Reach 2, looking upstream at bridge (outlet for Reach 3 is visible on the left)
